**RESULTS OF THE POST-APPLICATION
VEGETATION SURVEY OF GOOSE BAY,
NEW YORK**
FINAL REPORT

GOOSE BAY RECLAMATION CORPORATION

Lee H. Harper and Anne Johnson
Riveredge Associates, LLC, and
Riveredge Environmental, Inc.
58 OLD RIVER RD.
MASSENA, NEW YORK 13662

September 2015

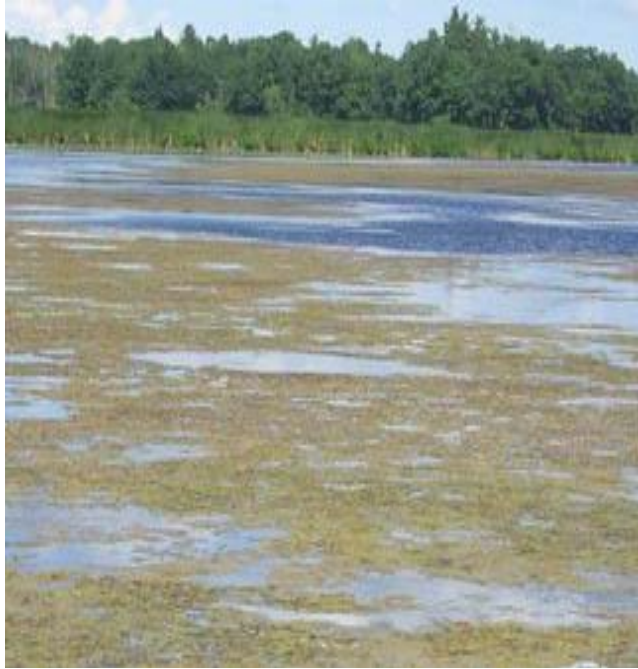
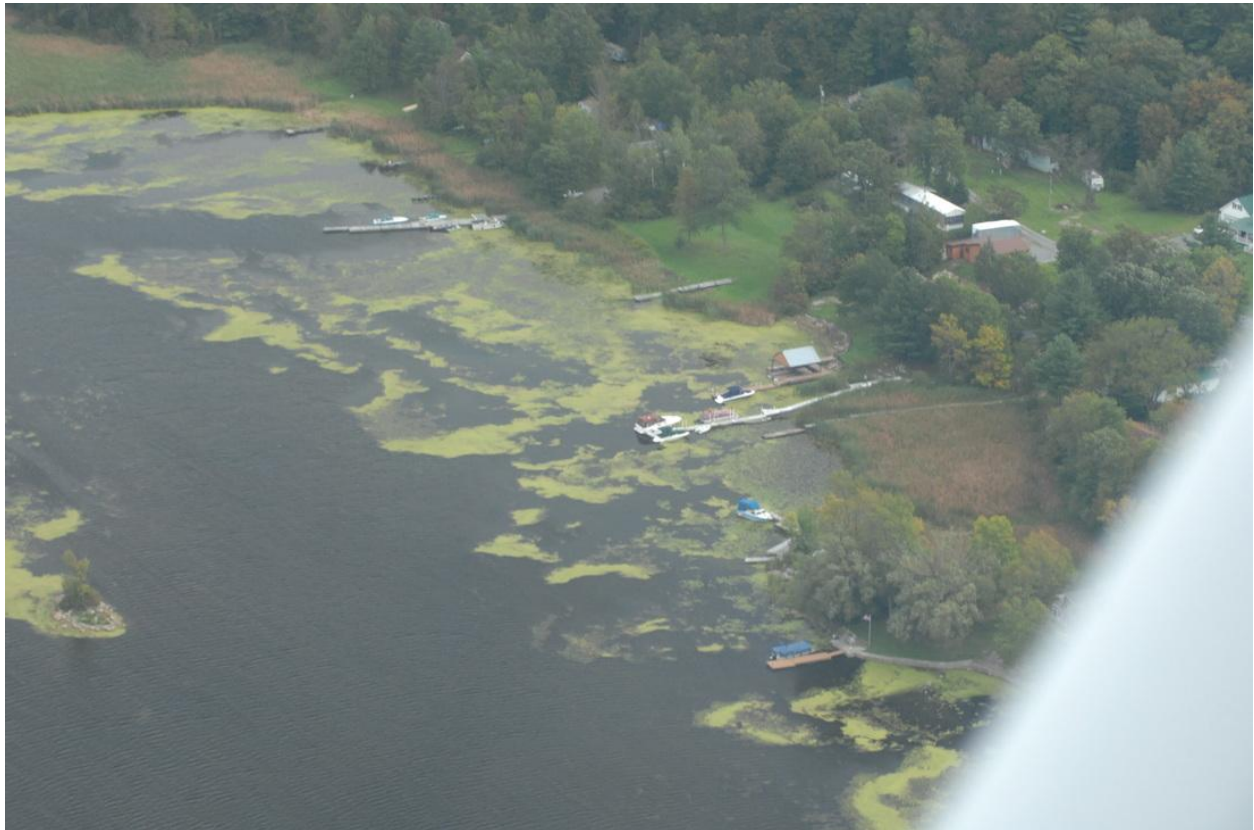
FIGURE 3. EURASIAN WATER-MILFOIL AT GOOSE BAY.

The appropriate applications were filed and permits obtained from NYSDEC to proceed with the application of the herbicide to a maximum of 40 acres in the vicinity of Little Goose Bay at the upwind end of the bay where milfoil was known to be extensive (Figures 3 and 4). Riveredge performed a pre-application bathymetric survey to determine the amount of herbicide to use, and on June 6, 2015, 3.24 tons of Renovate OTF was applied to 39 acres of Little Goose Bay using two boats (one airboat and one outboard-powered boat) (Figure 5).

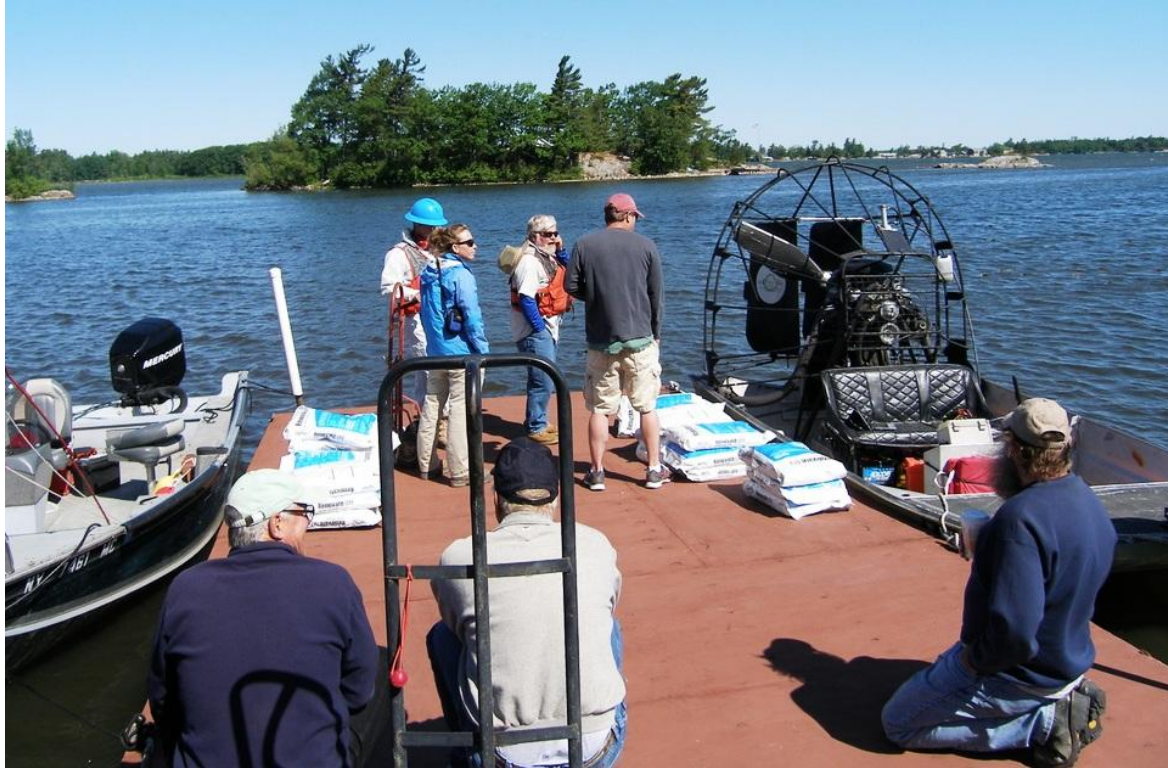
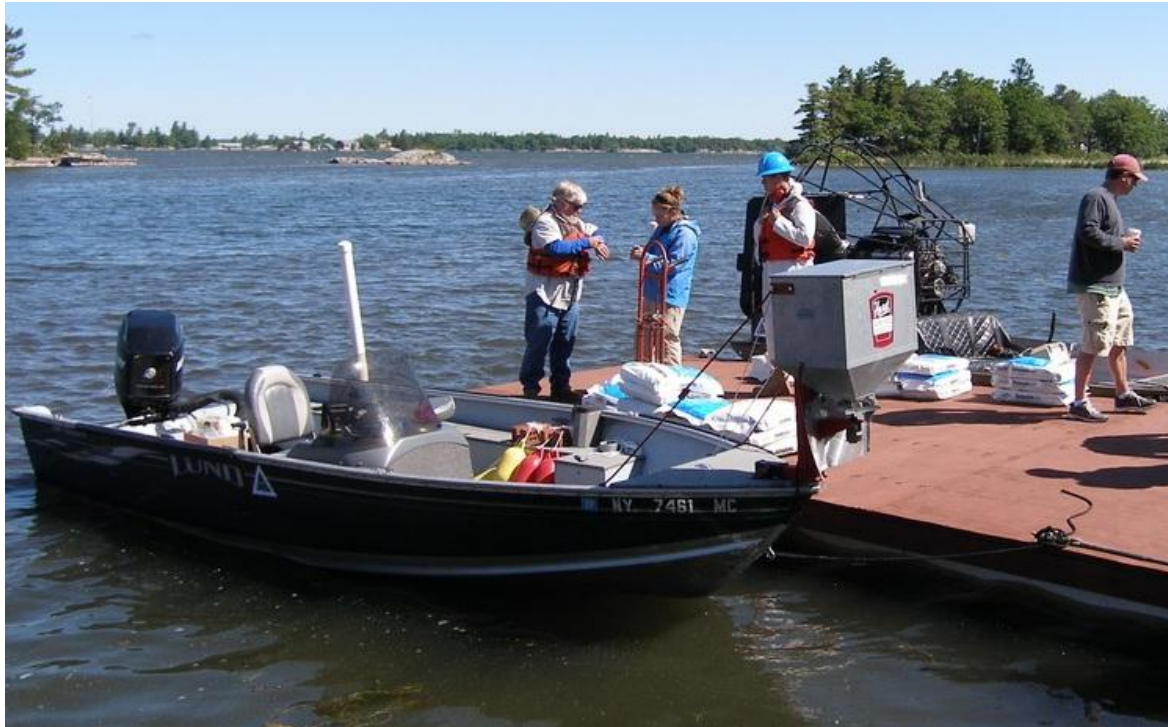
FIGURE 5. APPLICATION OF RENOVATE OTF TO LITTLE GOOSE BAY.

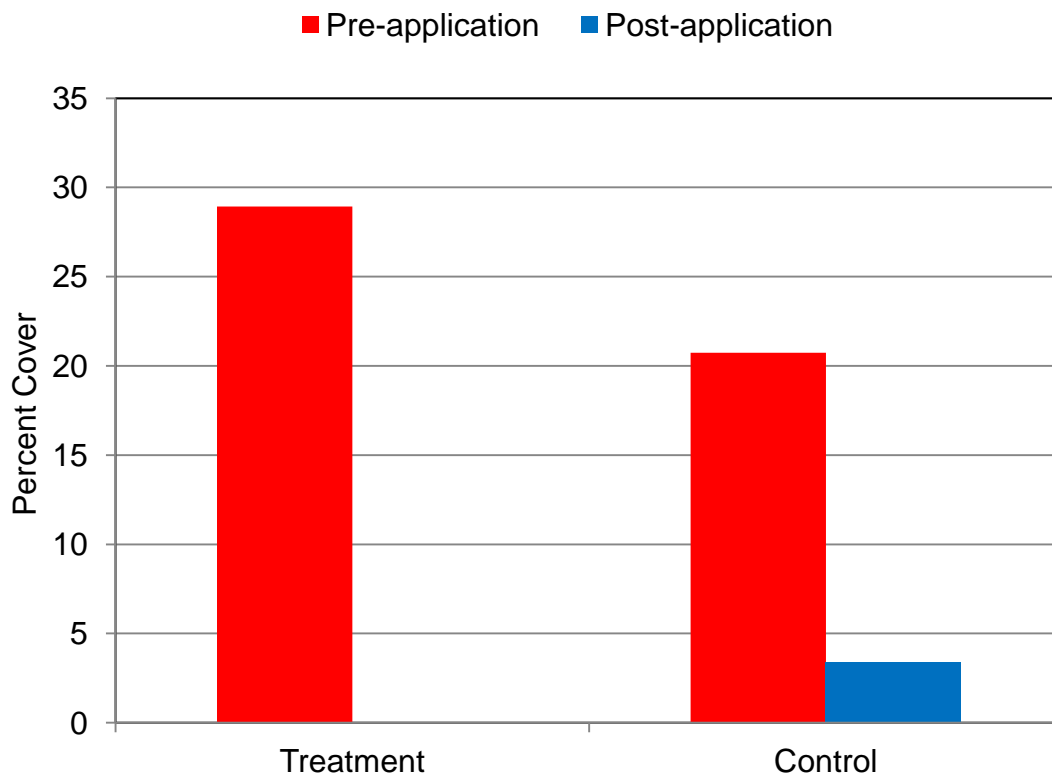
FIGURE 8. EURASIAN WATER-MILFOIL COVER IN PRE- AND POST-APPLICATION SURVEYS.

The average percent cover of Eurasian water-milfoil decreased after treatment with Renovate OTF (Table 1). In fact, no Eurasian water-milfoil was recorded in any of the 45 vegetation plots within the area treated (Table 1, Figure 8). Cover of other vascular plant species also decreased in both the treatment and reference areas.

Post-application survey results showed a significant difference between treatment and control areas ($p < .05$) using one way ANOVA. In addition, the percent cover of milfoil was significantly different between pre- and post-application surveys (Table 1).

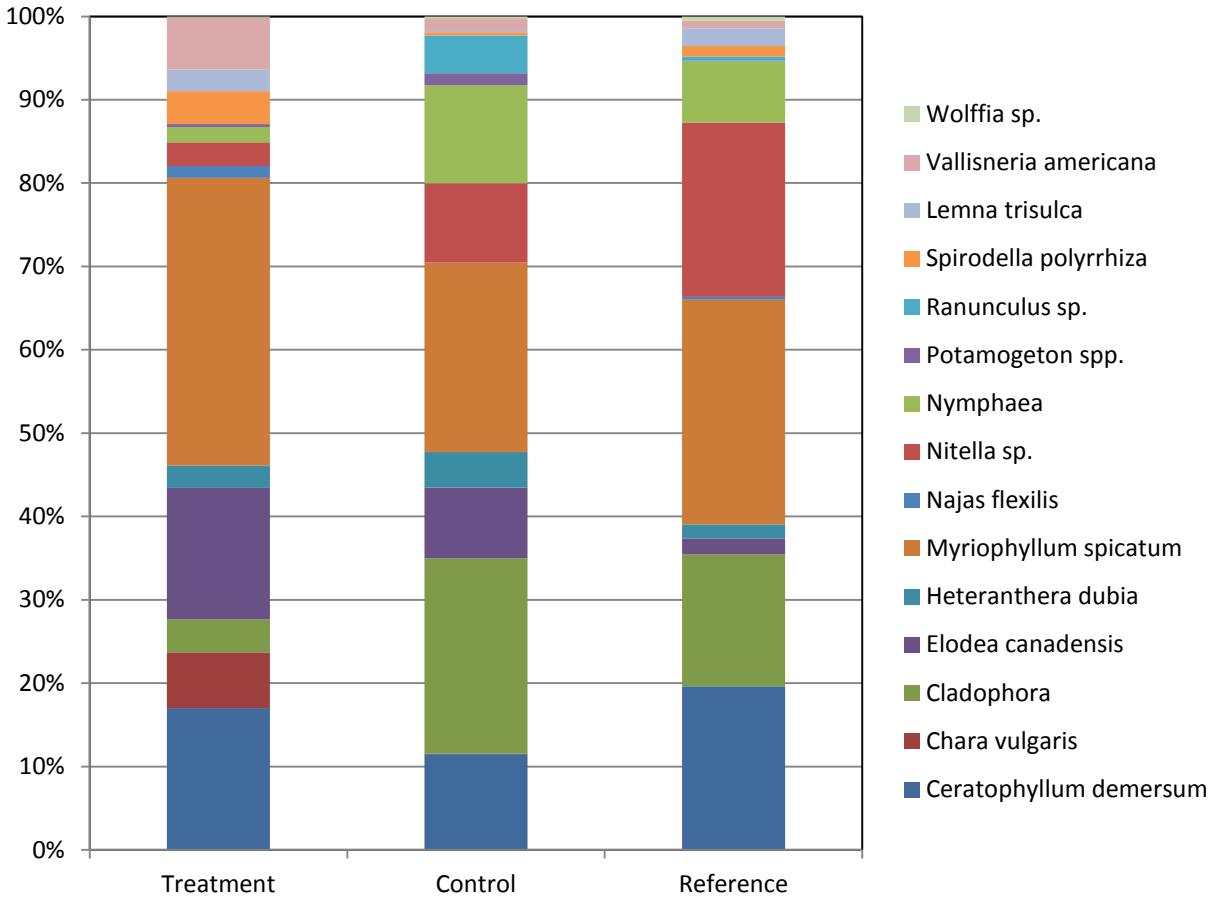
FIGURE 10. PERCENT COVER OF PLANTS FOUND IN THE PRE-APPLICATION SURVEY.

Percent cover of the next most dominant species within plots (*Vallisneria*) increased within the treatment area from 5.2% in 2014 to 15.5% in 2015 (Figures 9 and 10). Total cover of additional species was estimated to be higher in 2014 than in 2015.
